PERRY CITY DAM

ROLLS COUNTY, MISSOURI

PHASE I INSPECTION REPORT
NATIONAL DAM SAFETY PROGRAM

Name of Dam: Perry City Dam, Missouri Inv. No. 10675
State Located: Missouri
County Located: Ralls
Stream: Mace Branch of Lick Creek
Date of Inspection: September 30, 1978

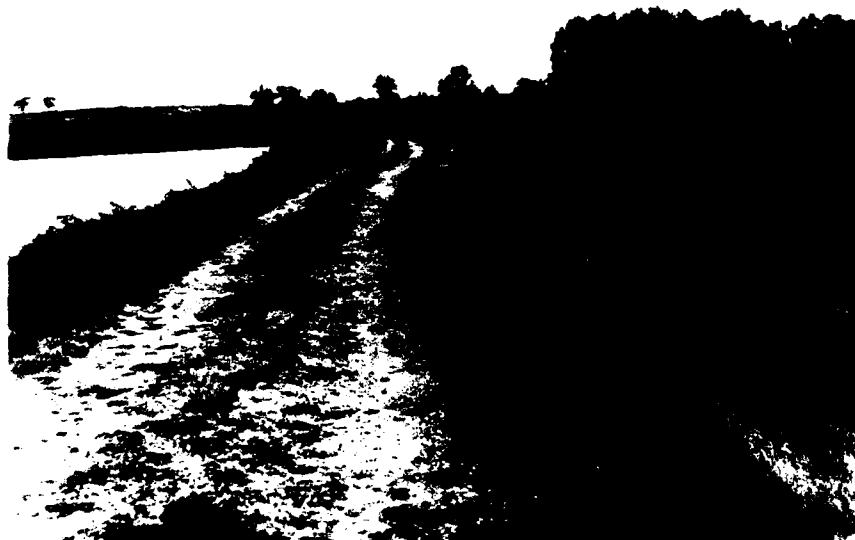
Photo 1 - View along crest of dam taken near right abutment.

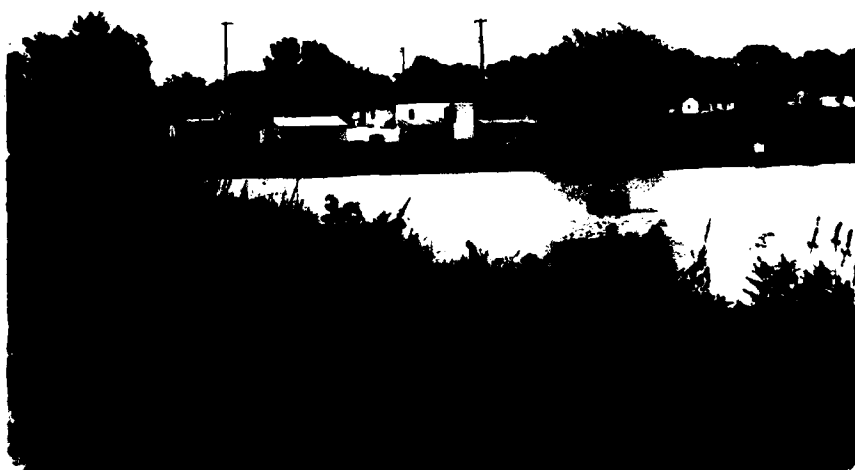
Photo 8 - Picture of treatment plant and pump house for water supply.
